Application Note:

Measurement of Corrosion

Micro Corrosion Pits Measurement

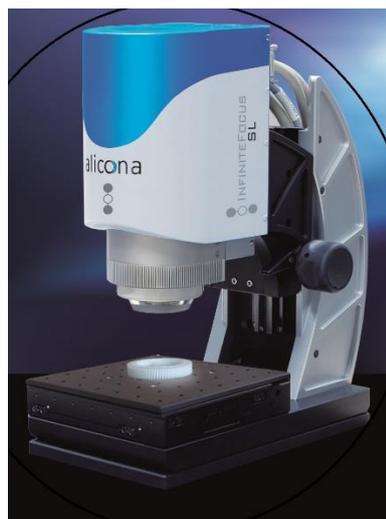
The system used for this application is the Bruker Alicona InfiniteFocusSL system as illustrated below.

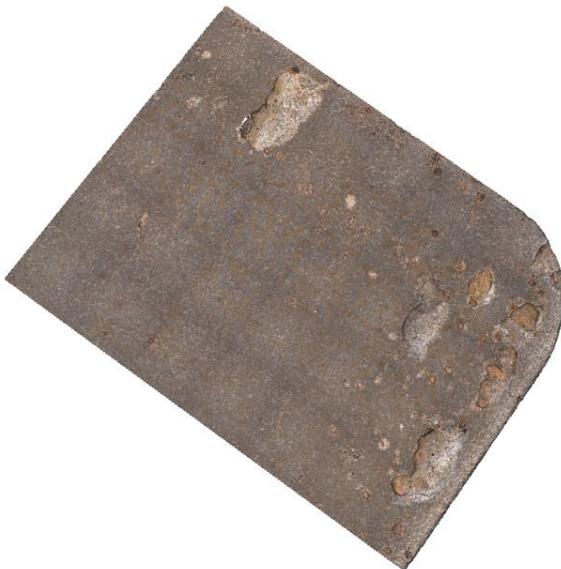
Figure 2

This allows the user to examine the surfaces. The definition of large and small pits can easily be seen in the data sets shown below in Figure 2. The left-hand image showing large corrosion pits and the right one displaying small corrosion pits. This is more graphically displayed when the data is displayed in pseudo color related to height in figure 3.

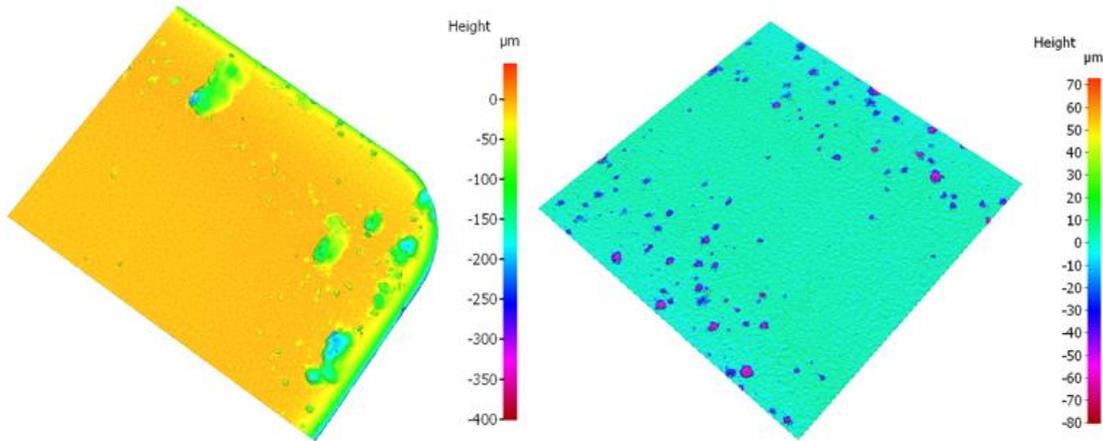
Figure 3 Data Sets Displayed in Pseudo Color related to height

From this data it can be clearly seen that analysis of the larger pits is relatively simple and that weight loss could be used for this over an area. However, using the Bruker Alicona system with the built-in analysis it is possible to provide full surface data. This displays number of defects, maximum depth, maximum projected area, maximum true area, maximum volume, percentage of defect area, shown in figure 4.

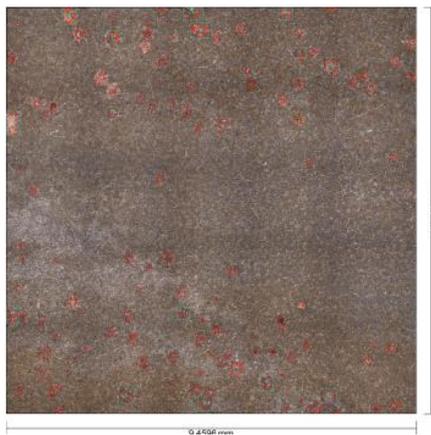
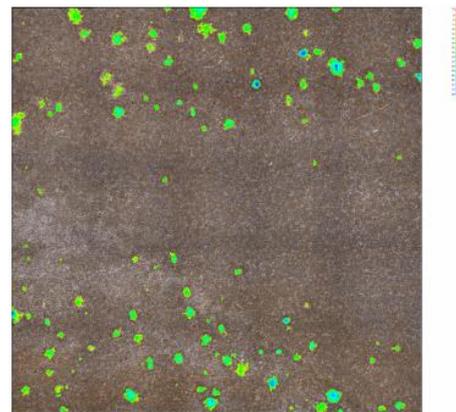
Figure 6

The smaller pits can also be analysed in the same way as shown below in figure 6

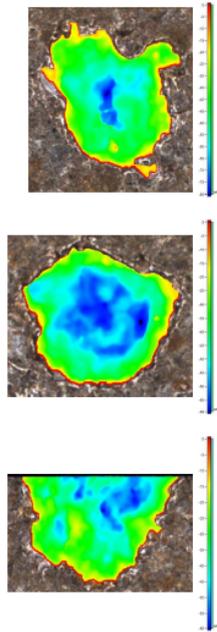
Figure 7

And specific results obtained for each pit individually, a sample of 3 pits is displayed below in figure 7.

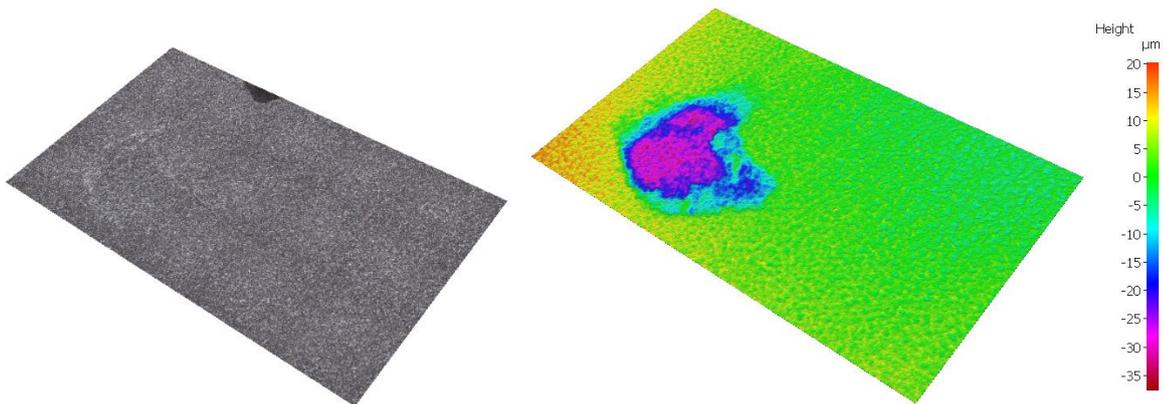
Figure 8

Using this optical method, it is possible to also easily identify shallow pits that may not always be visible to the eye, this is clearly seen in the 2 images displayed below in Figure 8, when pseudo color is applied the defect is clearly visible

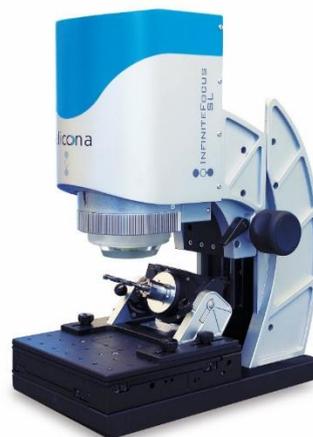
Using the optional real3D rotation system it is possible to carry out full 3D measurement of the length and circumference of the coupon providing the same measurement capabilities as with the flat coupon. The device is shown fitted to the measurement system in Figure 10 below.

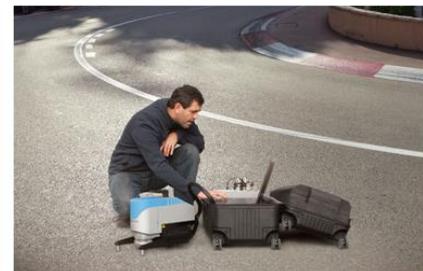
InfiniteFocusSL system with 50x50mm XY stage and fitted with rotation device. Info at <https://bit.ly/3sZS43H>

These measurements can be made using one of the 3 products shown below from Bruker Alicona. The InfiniteFocusSL will measure up to 50 x 50mm, the InfiniteFocusG5 plus will measure up to 200 x 200mm, the PortableRL allows in field measurement, e.g. on pipelines.
